**RE: Braddock Lake Dam (NJ Dam File No. 31-97)
Dam Assessment
Borough of Folsom, Atlantic County, NJ
PH #2016.001**

Princeton Hydro has been contracted to perform an individual assessment of the construction at Braddock Lake dam, to obtain a third-party opinion prior to closing out the project. I have prepared this report summarizing my findings based on a review of existing information and a site visit.

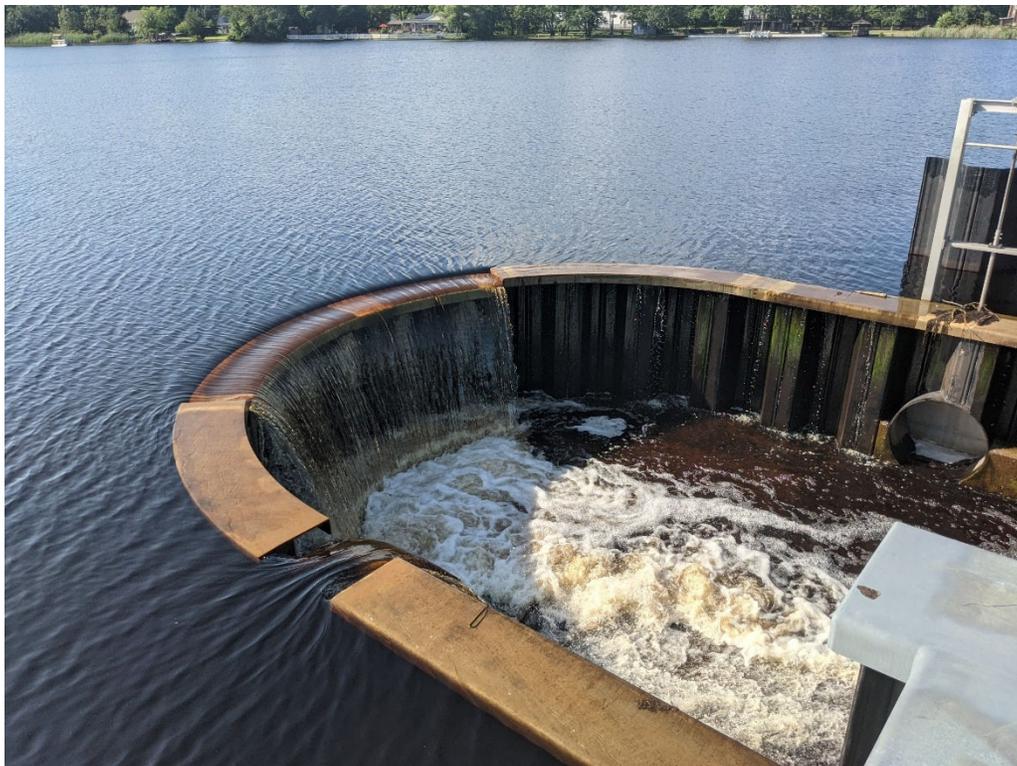
The primary spillway is an arch spillway constructed with sheet piling. At the time of the visit, water was flowing through the low flow weirs, with a depth of approximately two inches. Water was trickling over the pile cap. The sluice gate was in the closed position. The primary spillway appears to be of sound construction. No debris in or around the spillway was observed.

Figure 1. Primary Spillway operating at normal pool level.
Lake elevation ± 2 inches above low-flow weirs

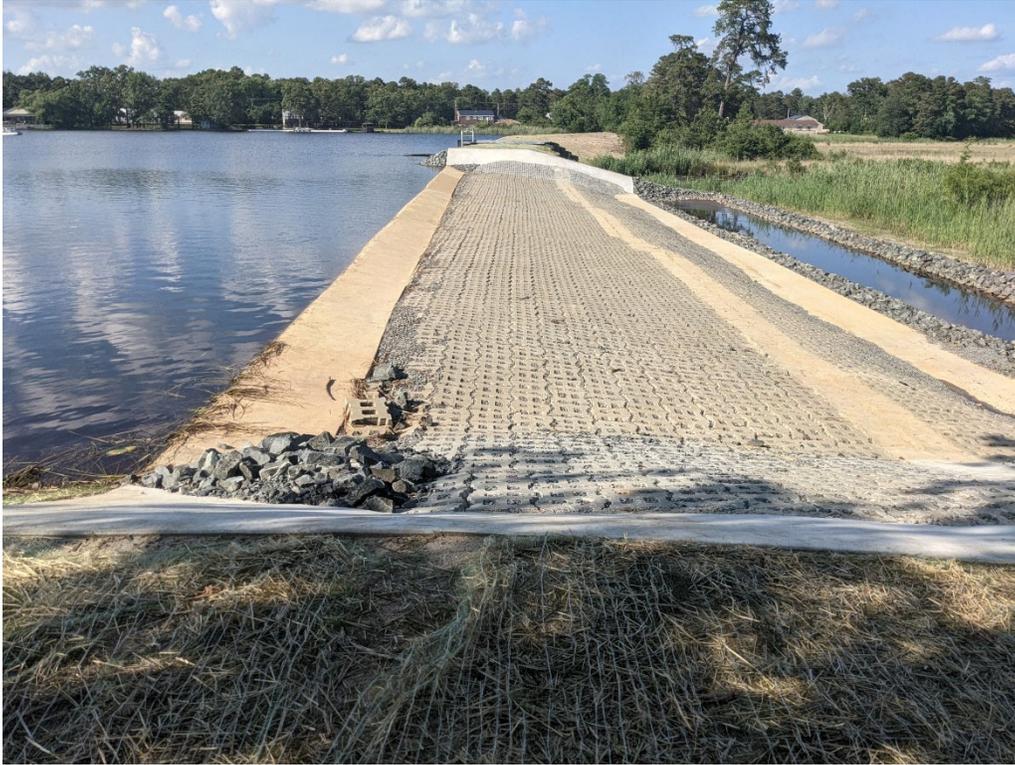
The secondary spillway has been armored with articulated concrete blocks (ACB), which are anchored to the slope by concrete at the lake level and toe of slope. The water level of Braddock Lake was approximately two inches below the top of the concrete. At the toe of the slope is a long riprap stilling basin, which serves to dissipate energy and prevent erosion from discharge during rainfall events. The stilling basin had standing water, approximately one foot deep. The side slopes are concrete, which tie the ACB mats to the dam crest and abutment. No debris in or around the spillway was observed.

Figure 2. Secondary Spillway operating at normal pool level.
 Lake elevation 2" below upstream concrete apron

Another area of concern is the river right corner of the secondary spillway. If you look at Figure 2 above, there are loose pieces of the articulated concrete block. The area has been backfilled with stone. I was unable to confirm that the ACB mats are properly toed in under the concrete apron in this spot. This area could be susceptible to erosion and undermining if storm events wash away the stone and block. I would recommend reaching out to the contractor to discuss and ensure that it was constructed properly or that it will be corrected.
