GEOTECHNICAL INVESTIGATION & REPORT for RECONSTRUCTION

CUSHMAN LAKE DAM

August 2012

Prepared For: Collings Lakes Community Association

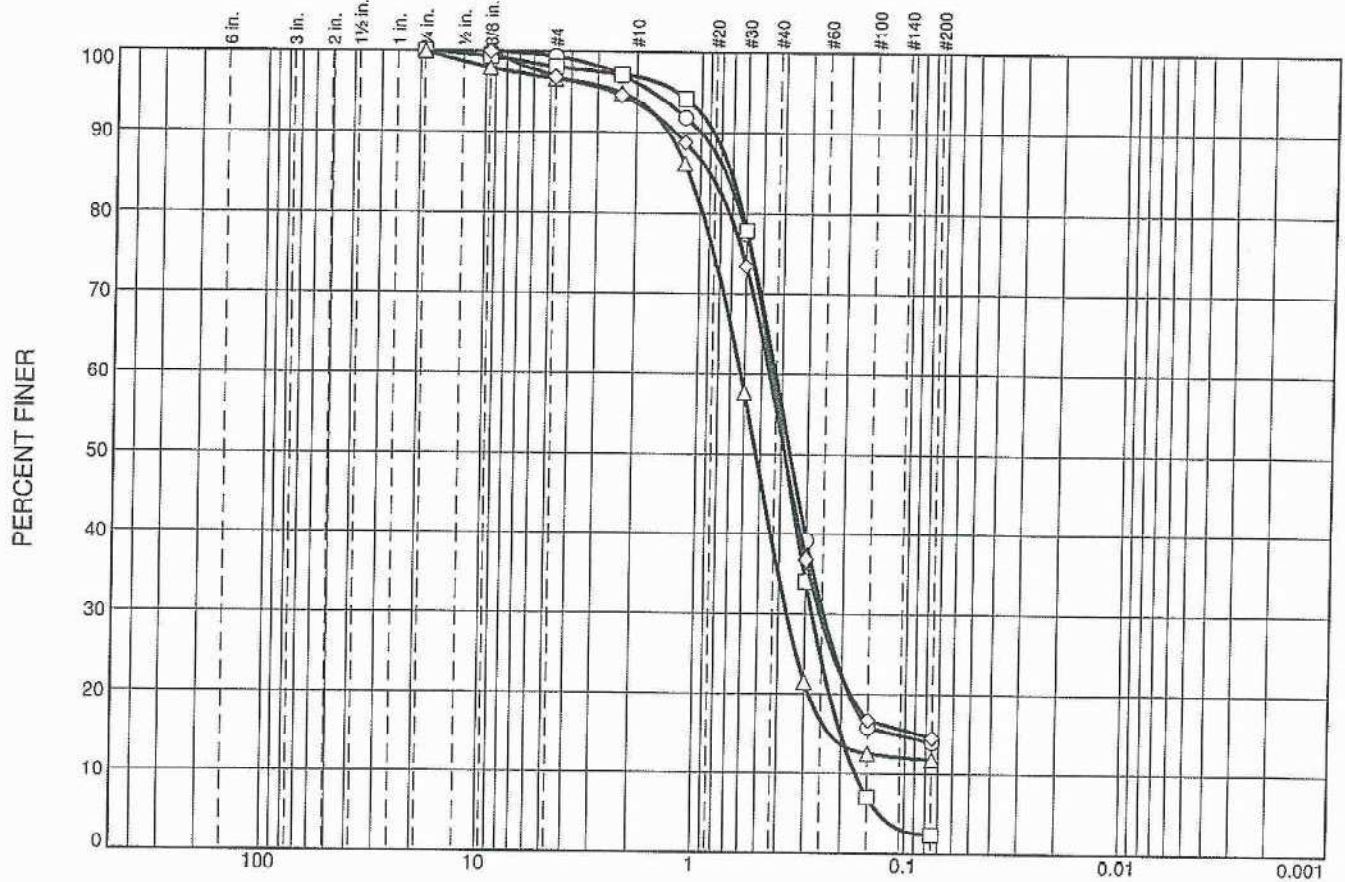
Figure 1

SOIL DATA					
SYMBOL	SOURCE	SAMPLE NO.	DEPTH (ft.)	Material Description	USCS
○	B-2	S-3	4	Yellowish brown coarse-fine SAND, little Silt	SM
□	B-2	S-8	18	Brown Medium to Fine SAND, Trace of Silt, Trace of Gravel	SP
△	B-3	S-2	2	Yellowish brown coarse-fine SAND, little Silt, trace fine Gravel	SM
◇	B-3	S-4	6	Brown Medium to Fine SAND, Trace to Little Silt, Trace of Gravel	SM
