June 17, 2025

CLCAX19001

**RE: Cushman Lake Dam Modifications
Block 2609, Lot 1.01 & Block 2710, Lot 1,
Borough of Folsom, Atlantic County, NJ**

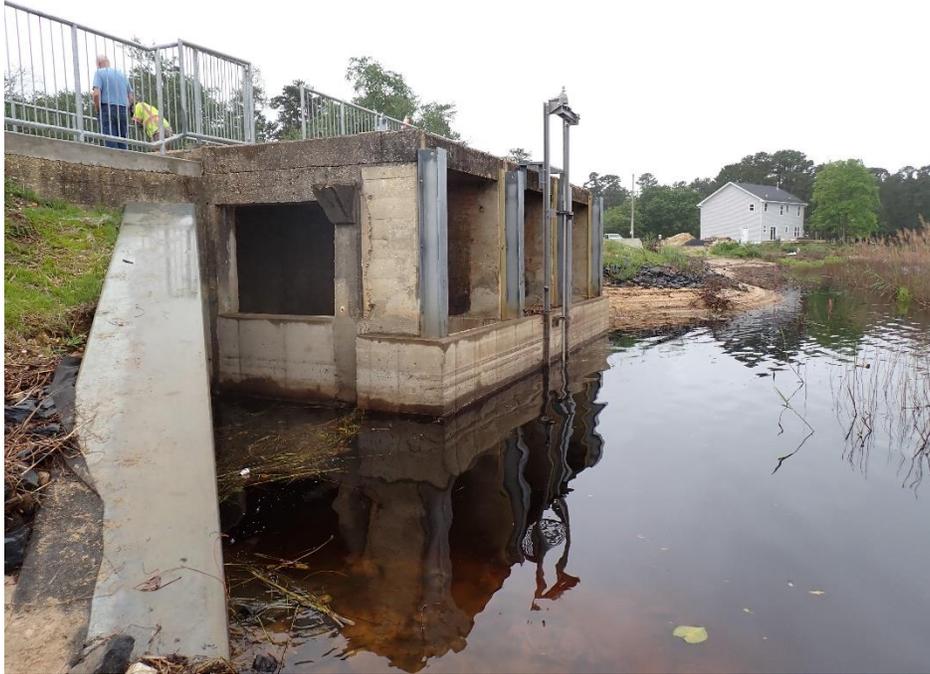
- Divers waded and probed along the west (lakeside) face of the structure, as well as along the corners of the concrete wingwalls/sheet pile retaining walls, in order to determine if there was any apron/footing exposure or obvious undermining. The top of footing was found via probing through several inches of channel bottom material. There was no vertical exposure or undermining observed. There were no significant defects on the upstream face.

Photo 1: General view, lake side dam structure, northwest (upstream) face.

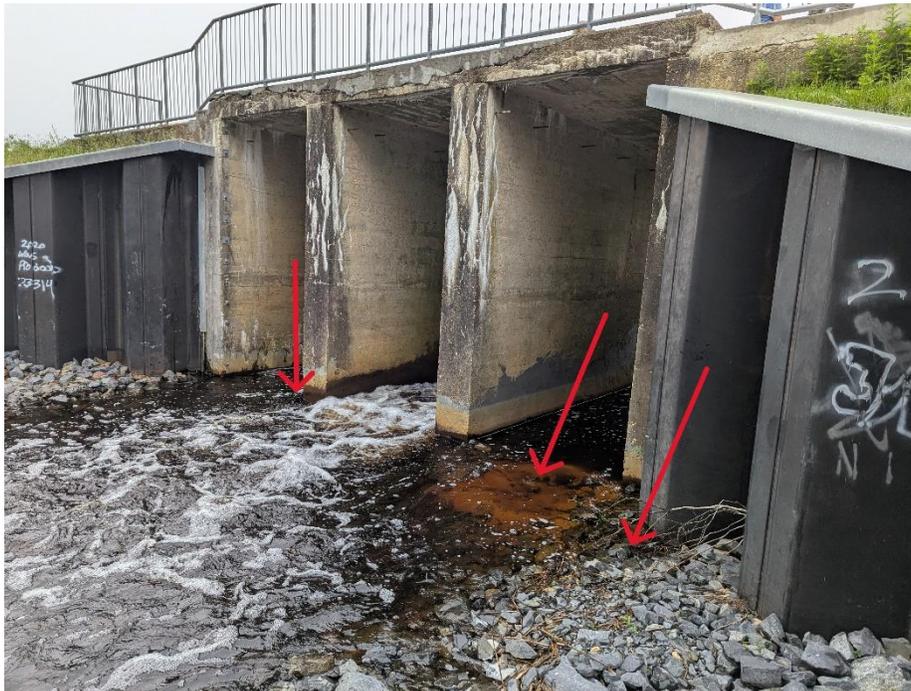
- Prior to divers entering the water and after the sluice gate was closed, the team observed several small boils and light sand/silt buildup at the downstream end, just east of the North Auxiliary Spillway and primarily through the riprap adjacent to the northeast wingwall.

boils and silt plumes were observed at the downstream end of the wall between Cells 1/2. This location was not previously observed, as it was likely obscured by the concentrated flow through Cell 2.

Photo 2: General view, lake side dam structure, east (downstream) face, prior to closing the sluice gate. Area of boils shown by arrows. Note, left location not observed until after wading and probing.

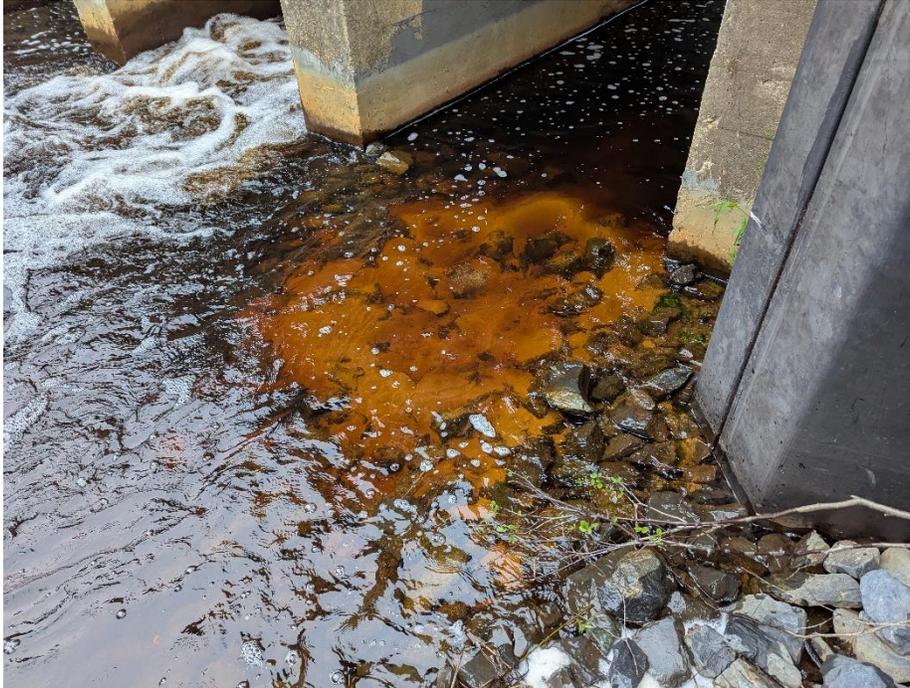
Photo 3: Close-up of boils at downstream end of Northern Auxiliary Spillway before closing the sluice gate.

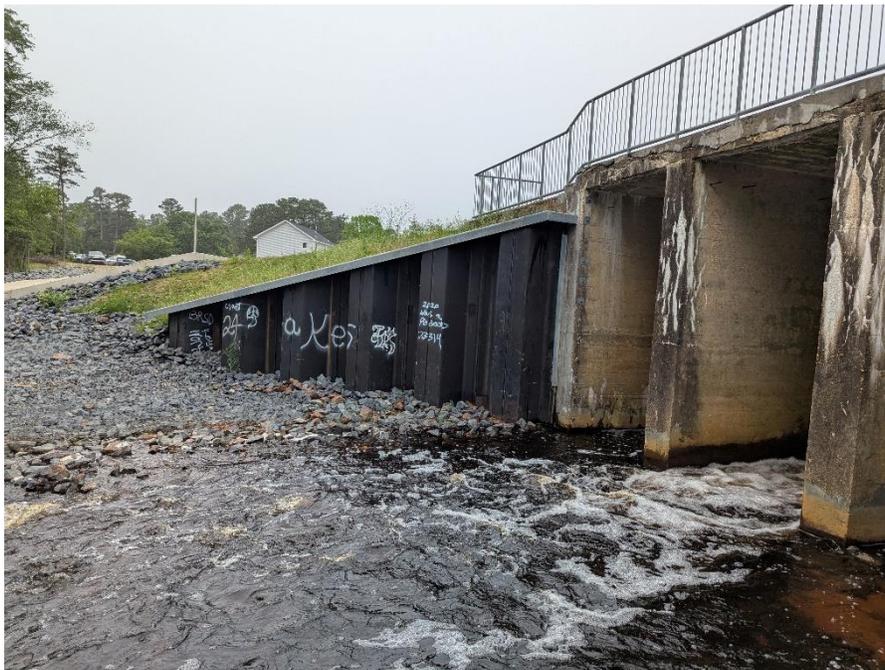
Photo 4: General view of downstream end prior to inspection activities. Note the water clarity.

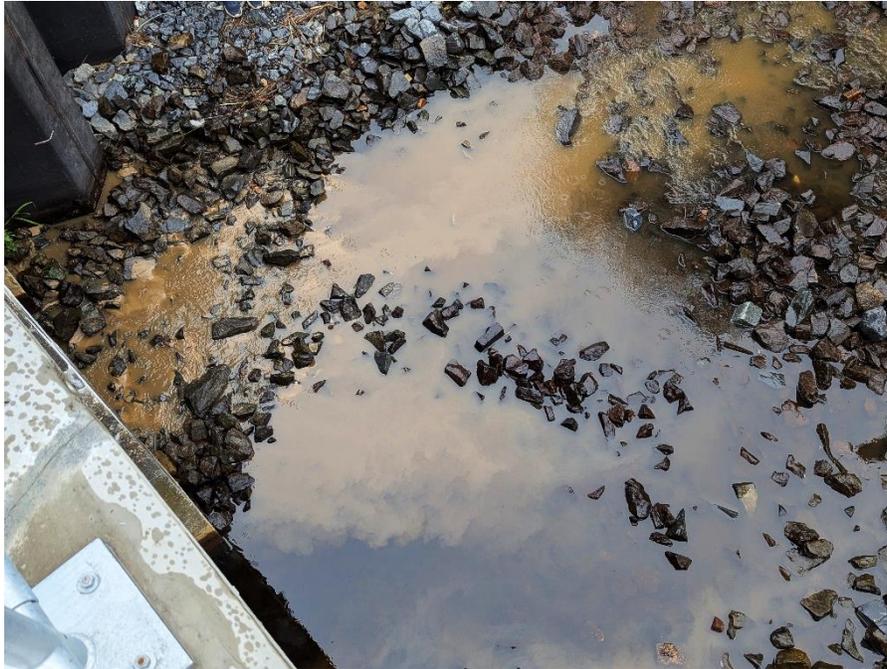
- Soon after probing along the west face and northwest corner (approximately 15 min.), visible plumes of fine silt were observed emanating from the downstream boils at the northeast wingwall.

Photo 5: Initial view of silt plumes forming at the downstream end, emanating from near the boils in Photo 3.

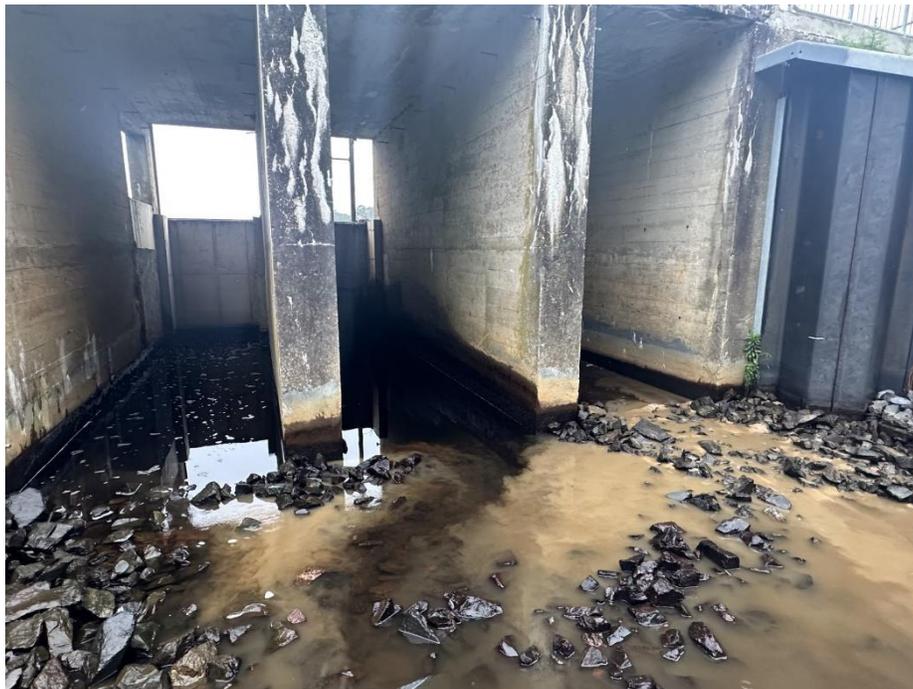
Although the dye was not successfully observed downstream, based on the large plumes of silt repeatedly observed after upstream wading and probing activities, it appears that the boils are likely caused by an upstream infiltration source (as opposed to groundwater).

Photo 6: Boils with silt infiltration at downstream end of Northern Auxiliary Spillway and south interior wall after wading and probing.

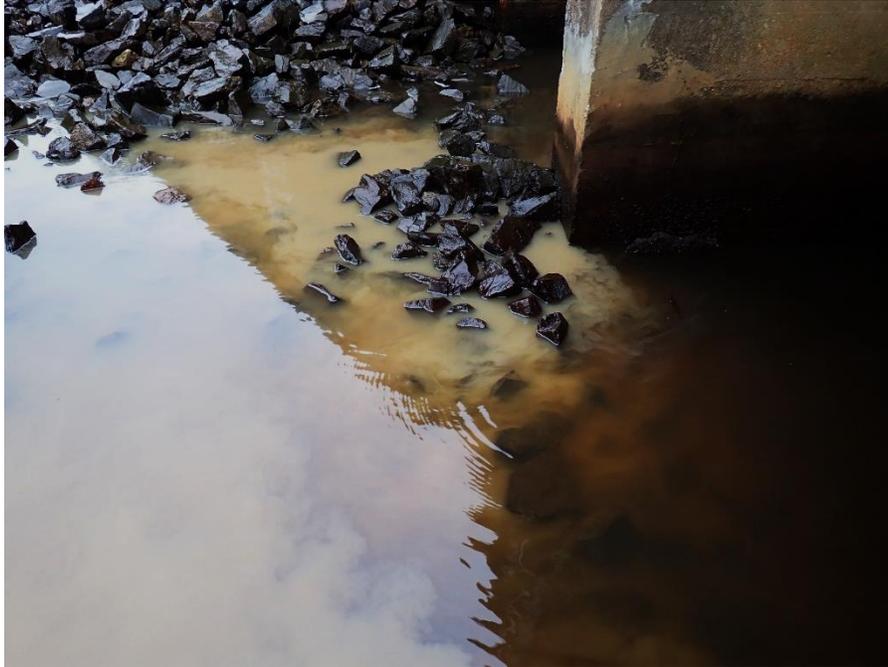
Photo 7: Detail view of the boil and silt plume at the south wall of Cell 2.

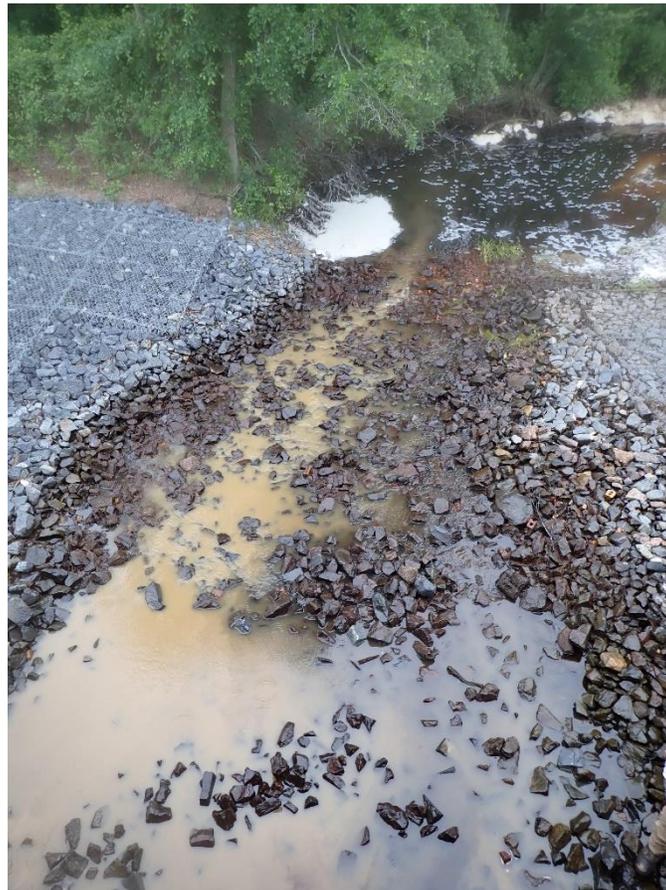
Photo 8: General view of downstream end after inspection activities. Note the widespread silt.

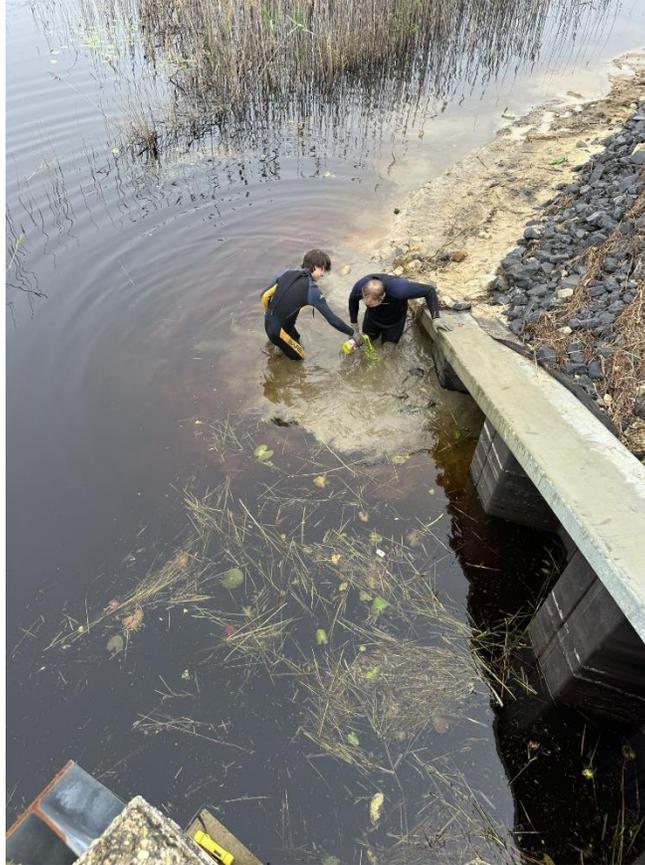
- Additionally, the divers placed concentrated dye and dye tablets along the upstream face and at the corners of the wingwall interfaces. No dye was observed downstream at the boil locations.
- The divers also “sounded” the concrete culvert walls for hollow areas with a hammer. The repairs are generally intact (no spalling/cracking) but exhibit numerous hollow areas on all cell walls, up to nearly full length x 18” to 30” high at/above the waterline.

Photo 9: Divers wading and pouring concentrated dye at upstream end of lake side dam structure, end of northwest retaining wall. Multiple dye locations tested.

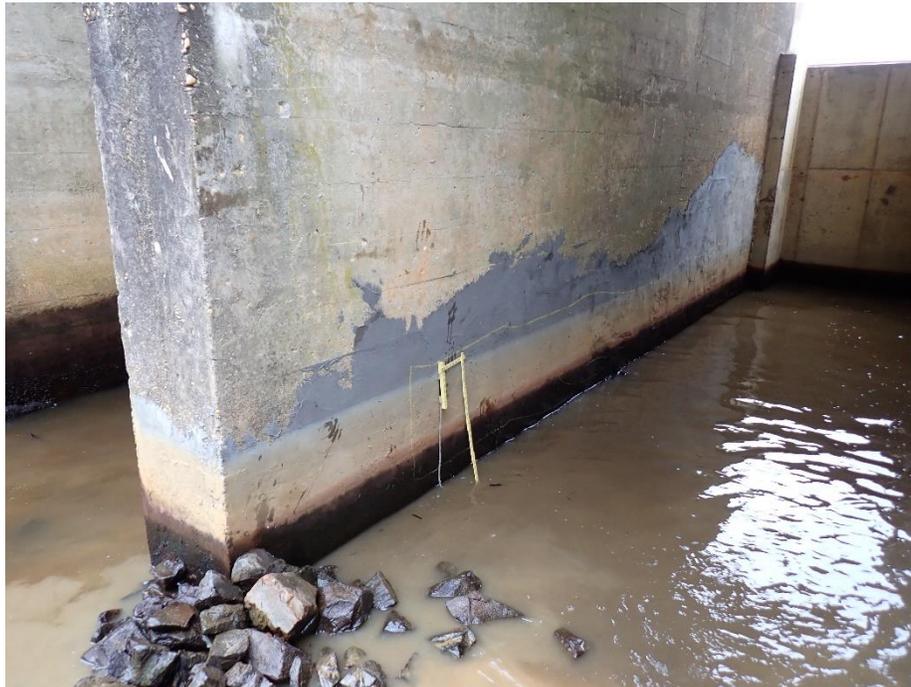
Photo 10: Cell 2, north face of south wall. Typical hollow soundings of rehabilitated concrete.
